DEPARTMENT OF TRANSPORTATION

Contract #: 04-0120F4Cty: SF/ALA Rte: 80 PM: 13.2/13.9File #: 1.28**WELDING INSPECTION REPORT****Resident Engineer:** Casey, William**Address:** 333 Burma Road**City:** Oakland, CA 94607**Report No:** WIR-028234**Date Inspected:** 23-Aug-2012**Project Name:** SAS Superstructure**OSM Arrival Time:** 700**Prime Contractor:** American Bridge/Fluor Enterprises, a JV**OSM Departure Time:** 1930**Contractor:** American Bridge/Fluor Enterprises, a JV**Location:** Jobsite**CWI Name:** Berry Drake**CWI Present:** Yes No**Inspected CWI report:** Yes No N/A**Rod Oven in Use:** Yes No N/A**Electrode to specification:** Yes No N/A**Weld Procedures Followed:** Yes No N/A**Qualified Welders:** Yes No N/A**Verified Joint Fit-up:** Yes No N/A**Approved Drawings:** Yes No N/A**Approved WPS:** Yes No N/A**Delayed / Cancelled:** Yes No N/A**Bridge No:** 34-0006**Component:** OBG 13 / 14 West**Summary of Items Observed:**

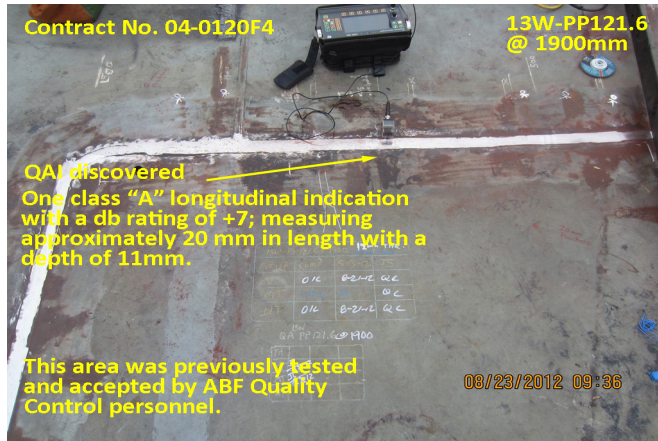
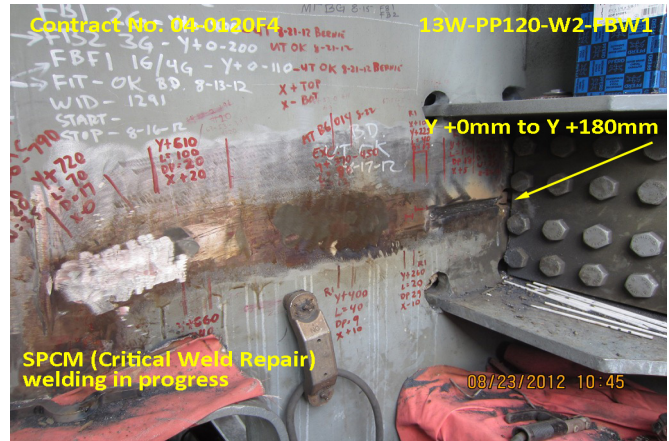
The QAI observed that welder 5892-Richard Garcia, was welding multi-Pass welds at 13W-PP120-W2-FBW1 (Floor Beam Web Plate) in the horizontal (2G) position. This QAI observed these parameters as defined in Repair Welding Procedure Specification WPS-ABF-WPS-D15-1004-Repair and RWR 201208-074 (2G) at the following locations.

The QC inspector Bernard Docena verified the joint geometry for these locations and found it to be acceptable, this information was relayed to the QAI. The welder then continued Pre-heat throughout the area during welding using a heat blankets at 120 degrees Celsius (250 degrees F) which was verified using a tempilstik and infrared gun by the QC. The welder was using the Shielded Metal Arc Welding (SMAW) electrode E7018 for the Complete Joint Penetration (CJP) weld in the horizontal (2G) position with 3.2 mm electrode with 127 amps. The welder utilized a power grinder and power wire wheel for the interpass cleaning. The QC inspector for this location was Bernard Docena and was observed verifying and documenting the welding parameters for this location, along with overseeing the welding operations. At the time METS observation was performed. No issues were noted by the QAI

The welder was grinding the starts and stops between weld layers to a bright metal as well as performing PWHT. The location was still in process at the end of this QAI's shift.
